# LAWRENCE TECHNOLOGICAL UNIVERSITY

## INSPECTION AND DETERIORATION OF BRIDGE DECKS CONSTRUCTED USING STAY-IN-PLACE METAL FORMS AND EPOXY-COATED REINFORCEMENT

Testing and Research Section  
Construction and Technology Division  
Contract # 2002-0134

**October, 2004**

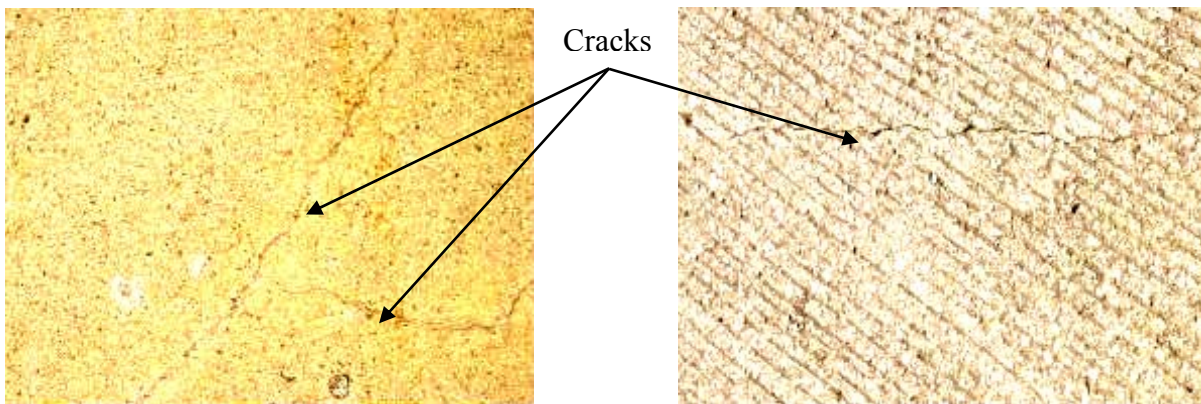
The bottom surface of the deck slab had cracks propagated transversely, longitudinally and diagonally (Figures 3.9 a, b and c). A thick layer of light colored material filled the cracks and spread in the direction of the bridge slope (Figure 3.9d). Some of the cracks also had corrosion traces. The drainage holes had corrossions in the deck without SIPMF (Figure 3.9e).

a. Longitudinal and transverse cracks

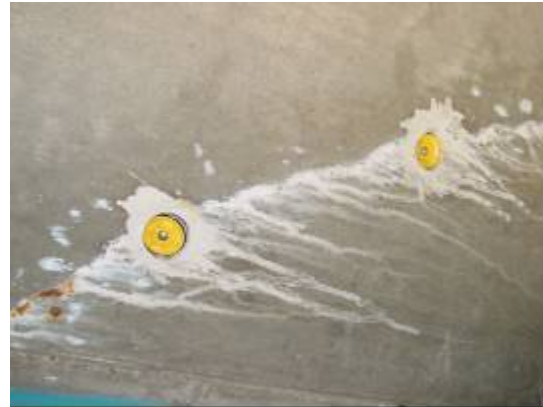
d. Cracks with corrosion and white traces in the direction of slope

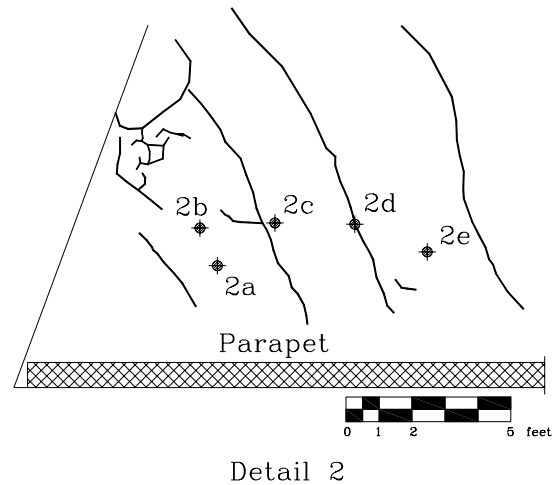
Figure 3.22. Map of cracks at coring locations for Bridge Deck Number 2 (Structure No. S03-81041)

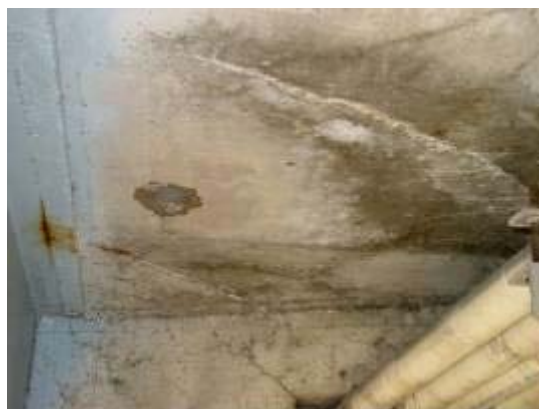
Figure 3.28. Rust traces on the bottom surface

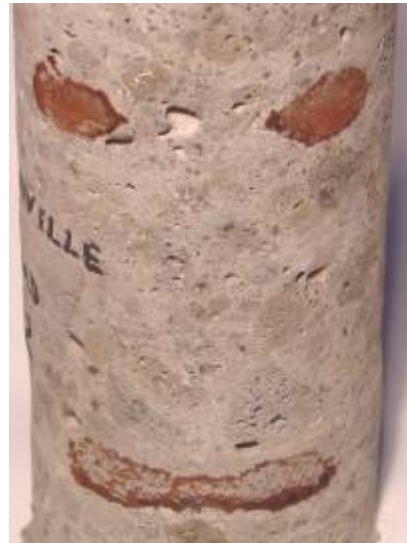
Figure 3.36. Core 2b rust in the reinforcement bars

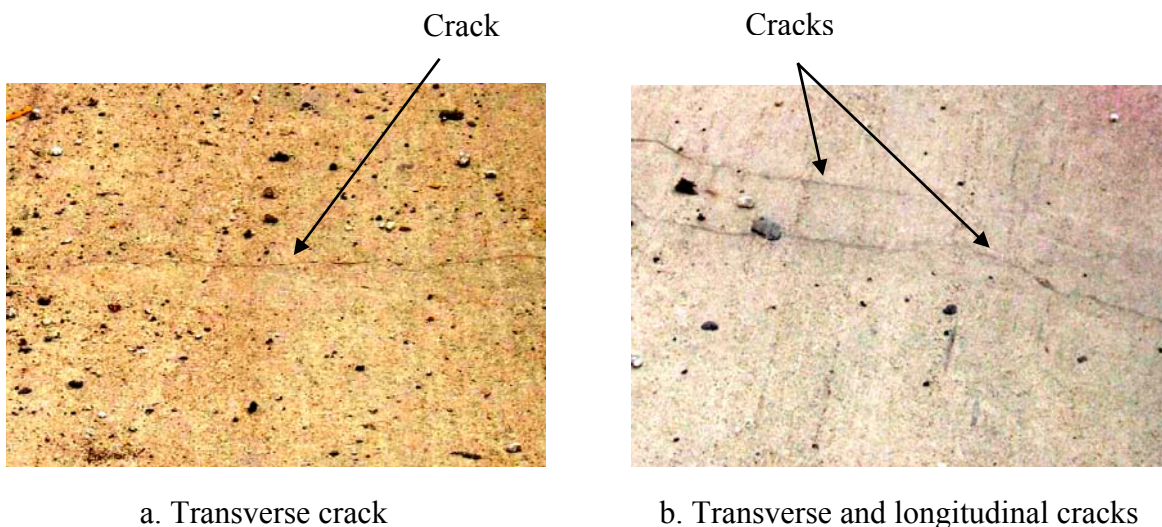
An inspection of the bridge was conducted for the top and bottom surfaces of the deck slab, steel beams and piers. Cracks were observed at the top surface of the concrete slabs (Figure 3.50). Cracks propagated transversely and longitudinally dividing the surface into small rectangles (approximately one square foot each) as shown in Figure 3.51. White and rust traces were encountered underneath the concrete slab (Figure 3.51). White traces were also encountered around the drainage pipe at the bottom surface (Figure 3.51). In some locations, the concrete cover was deteriorated and the steel reinforcement bars were exposed and rusted (Figure 3.52). The bottom surface of the cantilever deck slabs had white traces and the reinforcement bars had corrosion traces (Figure 3.53).

Figure 3.50. Cracks propagated on the top surface

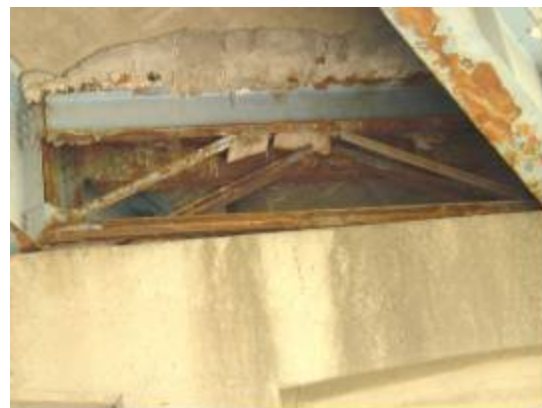
b. Rust traces

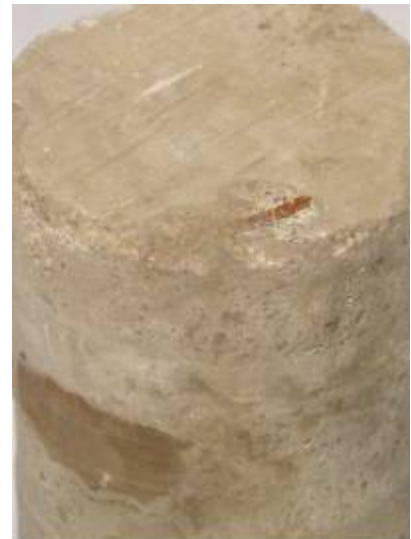
Figure 3.66. Pop-out in concrete  
Core 3e

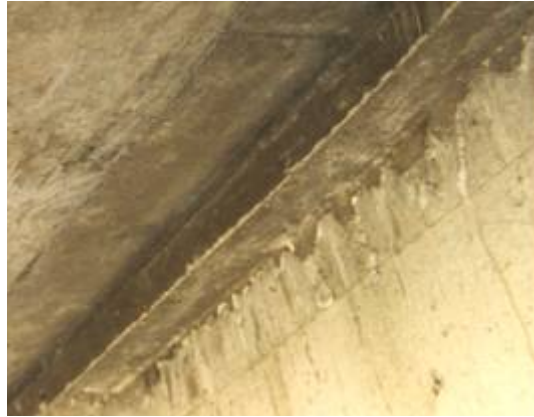
Figure 3.71. Good concrete condition

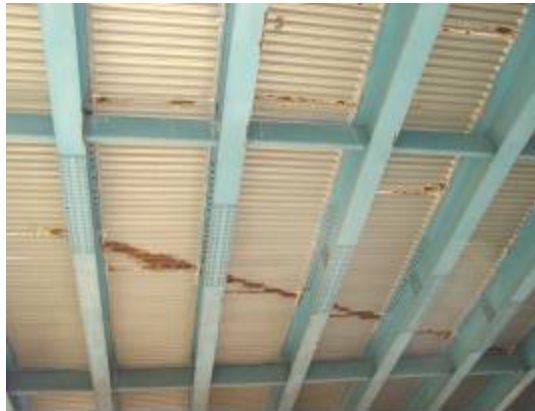
a. Corrosion in the SIPMF oriented diagonally

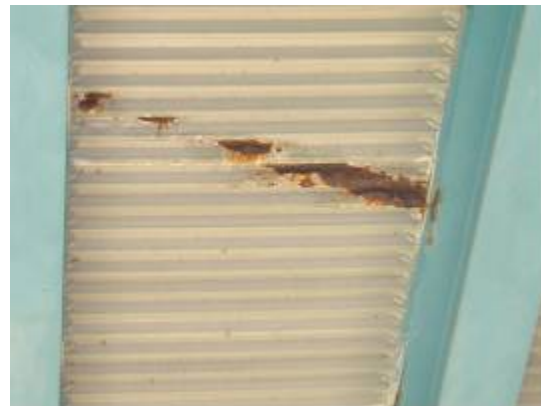
c. Corrosion and white traces in the SIPMF

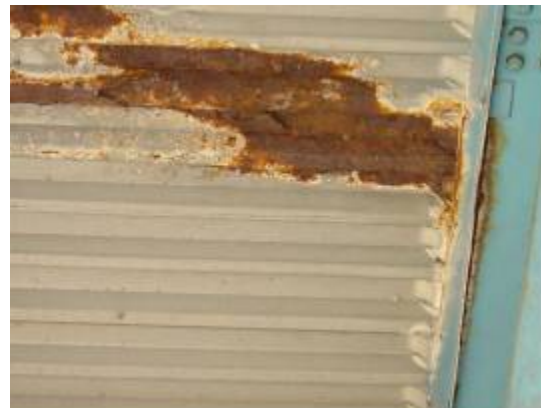
c. Corrosion in SIPMF and steel beam  
at the connection

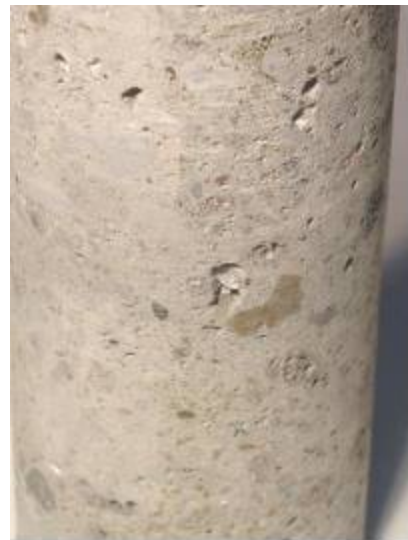
b. Large region of voids

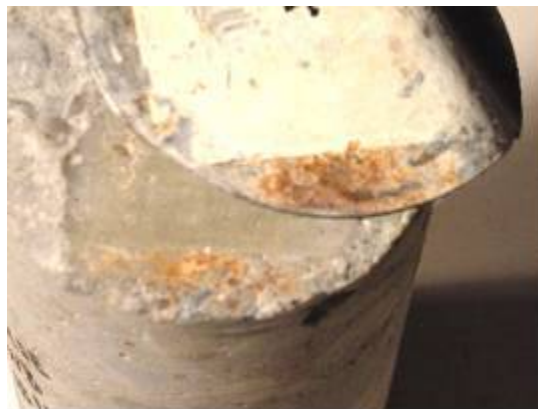
Figure 3.153. Core 9d rust traces on SIPMF and concrete

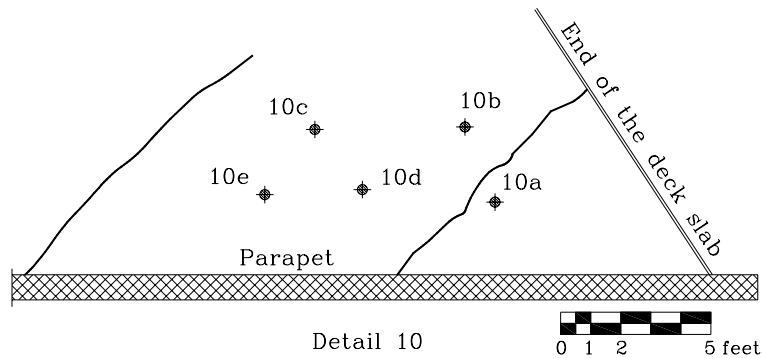
Figure 3.160. Map of cracks at coring locations for Bridge Deck Number 10 (Structure No. R03-25132)

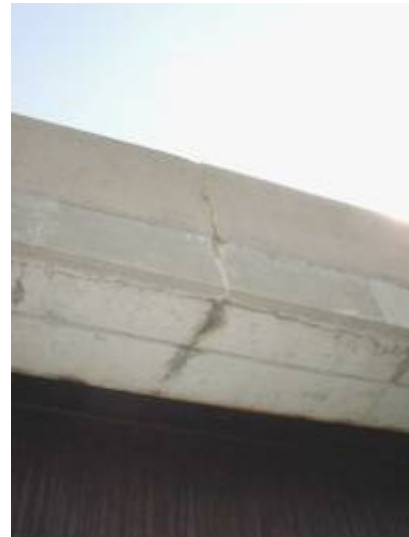
Figure 3.164. Cracks with white traces propagated in the parapet and the whole depth of the slab

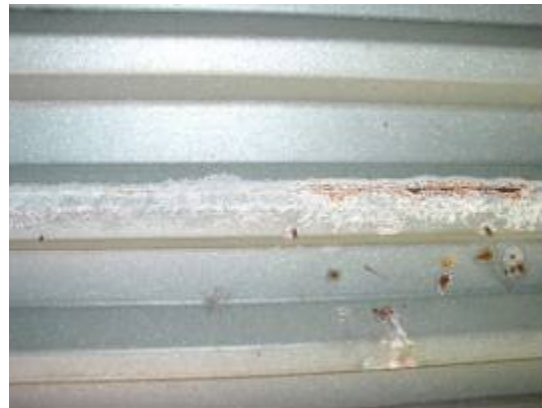
b. White and rust traces

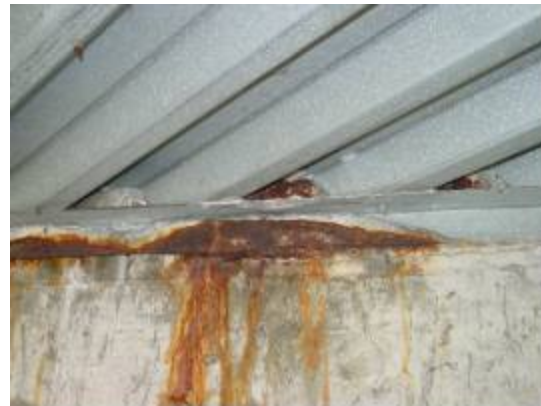
Figure 3.170. White and corrosion traces at the connection between SIPMF and the abutment

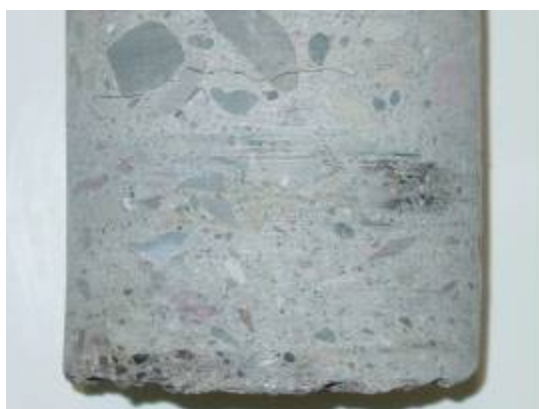
Figure 3.174. Core 10a horizontal crack.

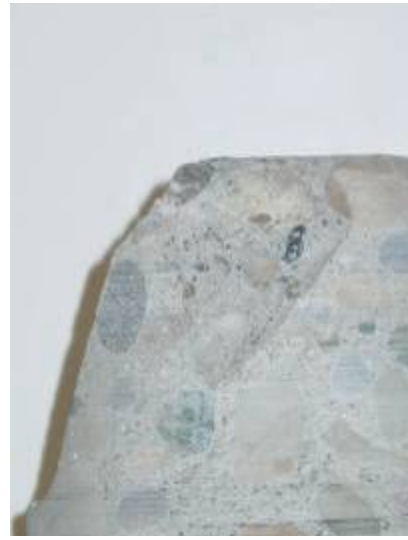
b. The concrete in the region of the valley of the SIPMF was partially broken

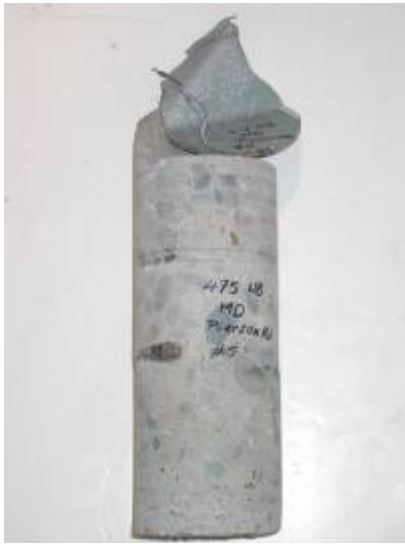
- 9.3 in. height (11.5 in. with the concrete in the region of the valley of the SIPMF).
- High porosity in the aggregate and cement paste.
- Many voids of 0.2 in. were observed.
- One region of honeycombing of 0.3 in. diameter was observed 8.6 in. from top.
- SIPMF was separated during the coring.
- One longitudinal cut of reinforcement bar located 4.5 in. from top.
- Traces of corrosion on the exposed reinforcing steel.

a. High porosity
